Safer Seward Highway Project  
Seward Highway MP 98.5 to 118,  
Bird Flats to Rabbit Creek  
Project No.: Z566310000/0A31034

# Environmental Assessment

*Appendix R: Environmental Database  
Review and Site Reconnaissance  
Progress Letter*

RE: ENVIRONMENTAL DATABASE REVIEW AND SITE RECONNAISSANCE PROGRESS  
LETTER, SEWARD HIGHWAY 98.5 - 118 CORRIDOR, ALASKA

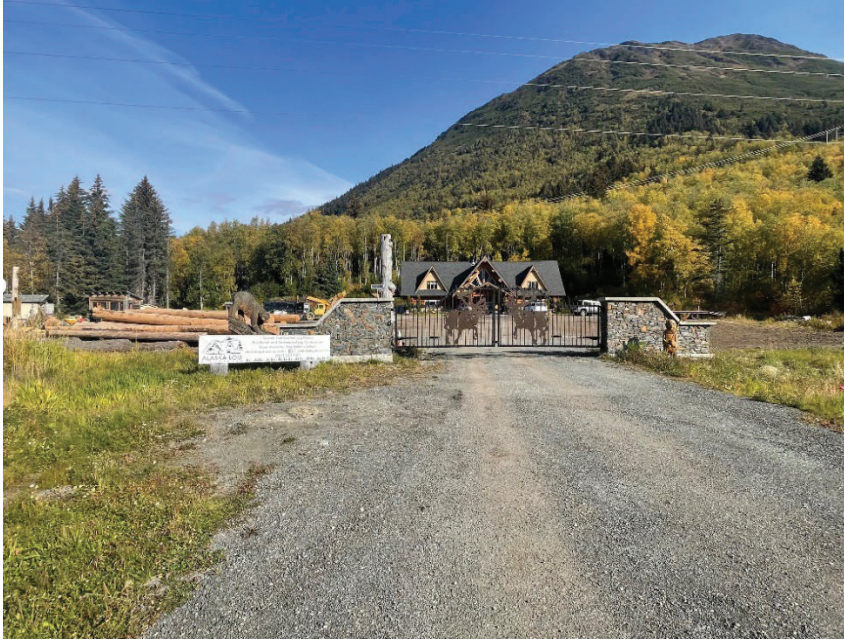
Alaska Log Structures, a log construction company, is located on the mountain side of the Seward Highway near Mile 100 of the XSC, at 29859 Seward Highway. Log homes are constructed onsite, deconstructed, and transported to other locations. There is one main structure and several outbuildings located on-site (Photo 1). Heavy machinery was observed at the site. Telecommunication wires and poles were observed running parallel to the Seward Highway (Photo 2).

Photo 1: Looking northeast at 29859 Seward Highway, located at Mile 100 of the XSC. (September 27, 2023)

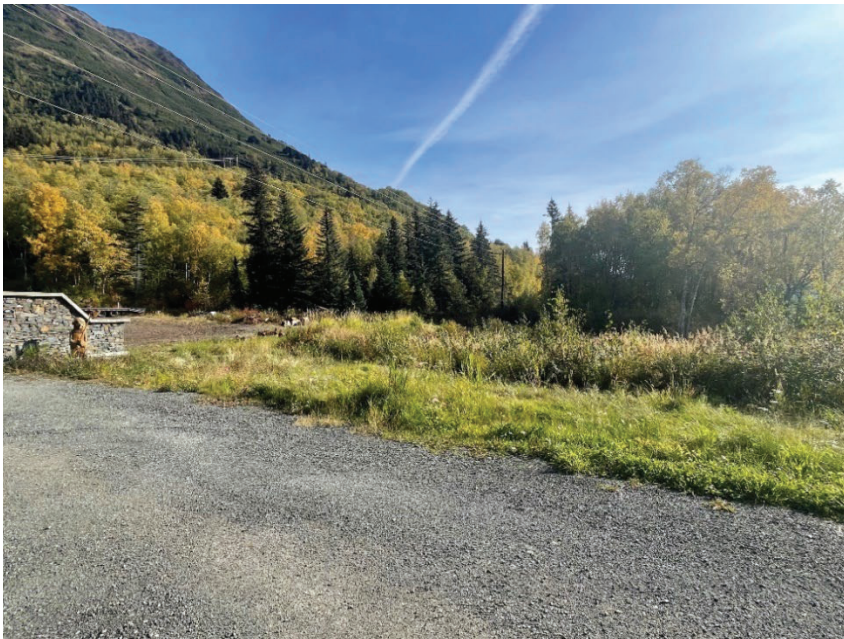
Photo 2: Looking east at telecommunication pole and utility lines running parallel to the Seward Highway along the northern boundary of the XSC at Mile 100. (September 27, 2023)

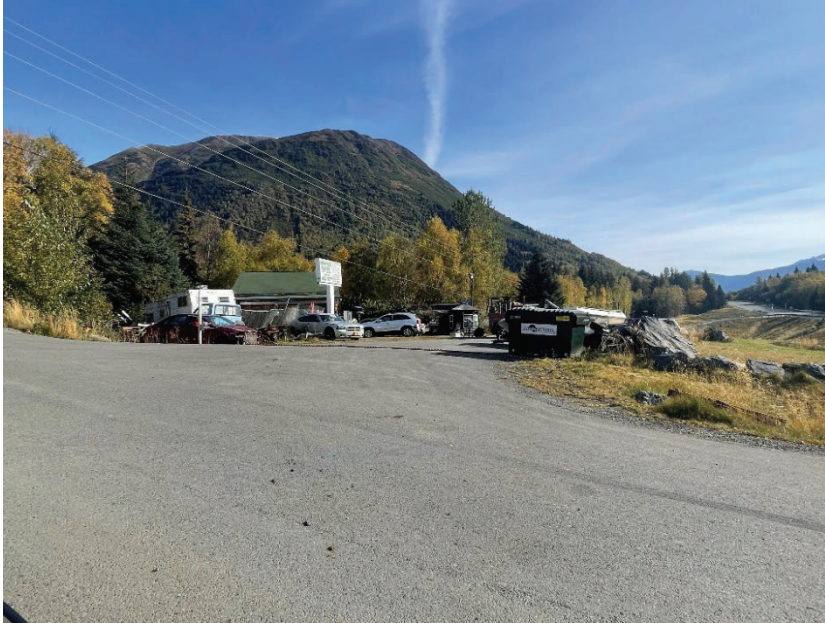
The Bird House Garage, an automobile repair and towing operation, is located near Mile 100.5 of the XSC at 156 State Park Road. Front end and tire repair, brake service, detailing, radiator repair, welding repairs, lube oil and filter changes occur at the site. Several parked cars, boats, a recreational vehicle, tires, engine parts, and 5 to 10- gallon gasoline canisters were observed at the site (Photos 3 and 4). Powerlines were observed running parallel to the XSC. Markings for a buried fiber optic cable were observed in this location (Photo 5).

Photo 3: Looking east at 156 State Park Road is located near Mile 100.5 of the XSC. Several parked cars, engine parts, a boat, recreational vehicle, and a refuse dumpster were observed at this location. (September 27, 2023)

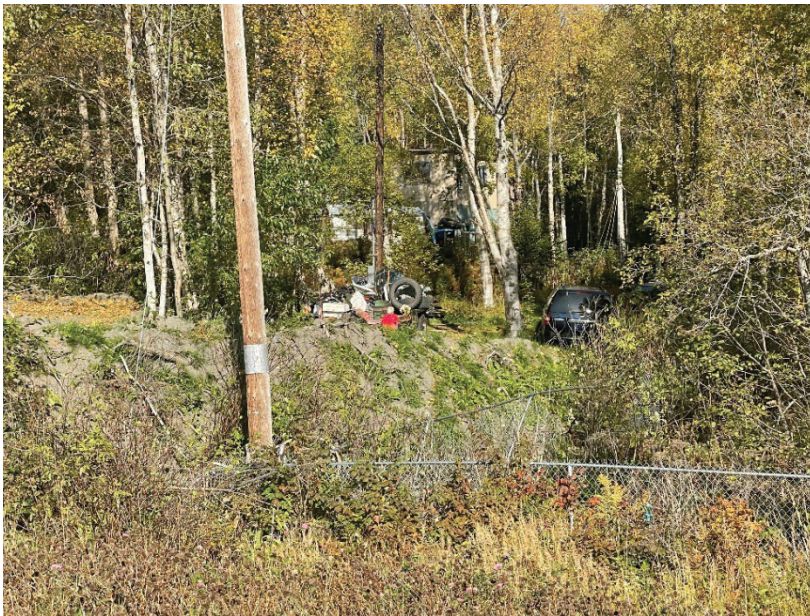
- Miscellaneous 5 to 10- gallon storage containers, storage tanks, parked vehicles, engine parts, and a parked boat were observed at various locations along the XSC. There is a potential that undocumented releases from these containers, storage tanks, and other items, could potentially impact the XSC and/or surrounding area.

Photo 4: Looking northeast at structures south of 156 State Park Road. Tires, engine parts, and 5 to 10- gallon gasoline canisters were observed at this location. (September 27, 2023)

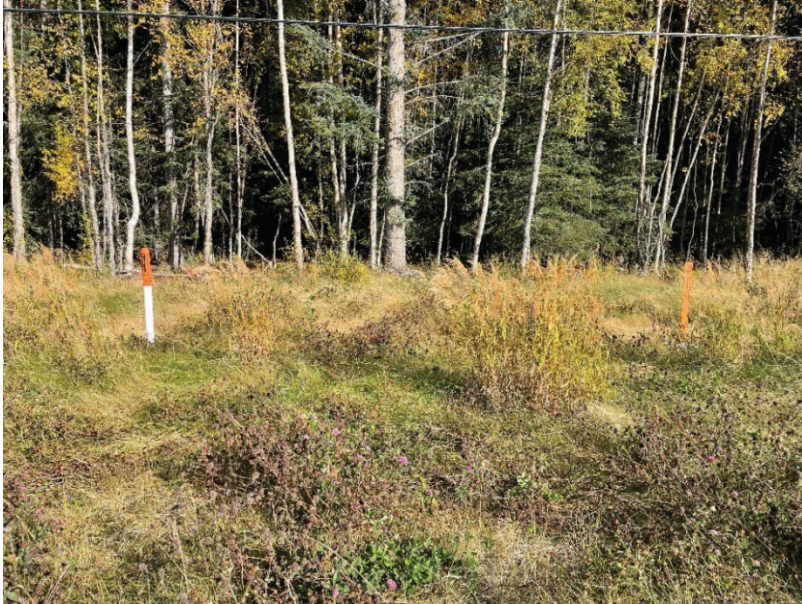
Photo 5: Looking northeast at buried a buried fiber optic cable along the Seward Highway near Mile 100.5 of XSC. (September 27, 2023)

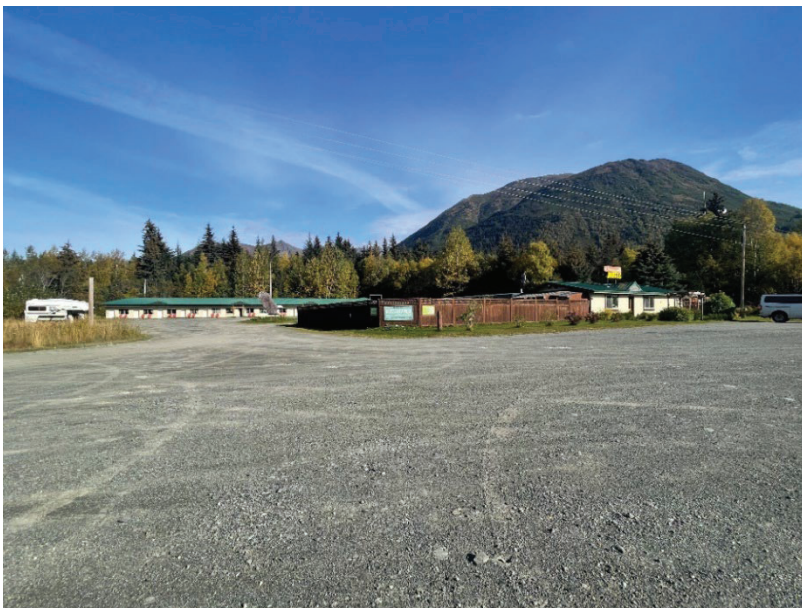
The Bird Creek Motel & RV park is located south of Sawmill Road, near Mile 100.75 of the XSC at 29433 Seward Highway (Photo 6). An unpaved parking lot for the Bird Creek Motel & RV park is located within the XSC boundary. Powerlines were observed running parallel to the highway, along the XSC boundary. The Bird Creek Motel is located adjacent to the XSC boundary, on the mountain side of the road.

Photo 6: Looking northeast at Bird Creek Motel & RV, located at 29433 Seward Highway near Mile 101 of the XSC. (September 27, 2023)

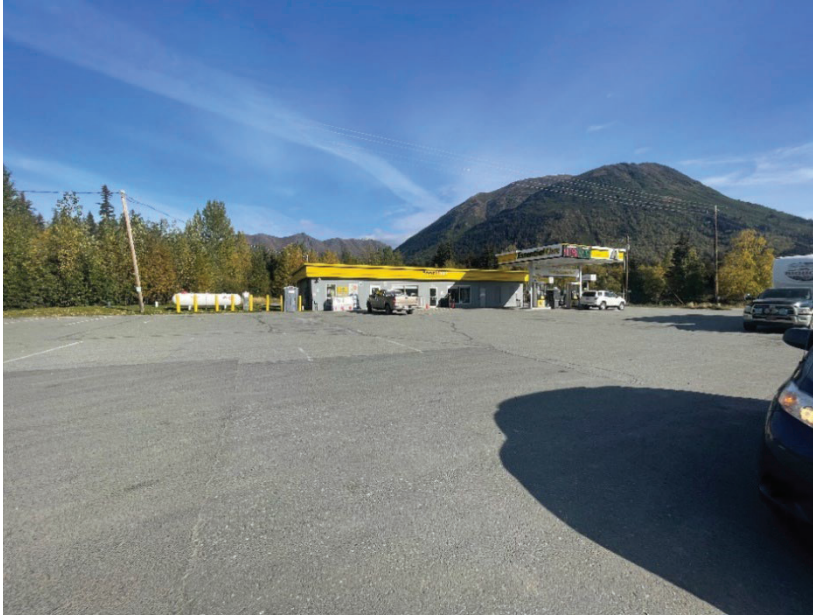
An Essential One filling station is located north of Sawmill Road, near Mile 100.75 of the XSC at 29383 Seward Highway (Photo 7). The filling station comprises a retail building, one canopy, four pump islands, one about 1,000-gallon propane above ground storage tank AST, and one approximately 15,000-gallon fenced-in AST (Photos 8 and 9). Due to the nature of the fence, the approximate 15,000-gallon AST could not be directly observed. The canopy and two pump islands are located on a paved parking area that appears to be within the proposed XSC boundary.

Photo 7: Looking northeast at Essential One, located at 29383 Seward Highway near Mile 101 of XSC. (September 27, 2023)

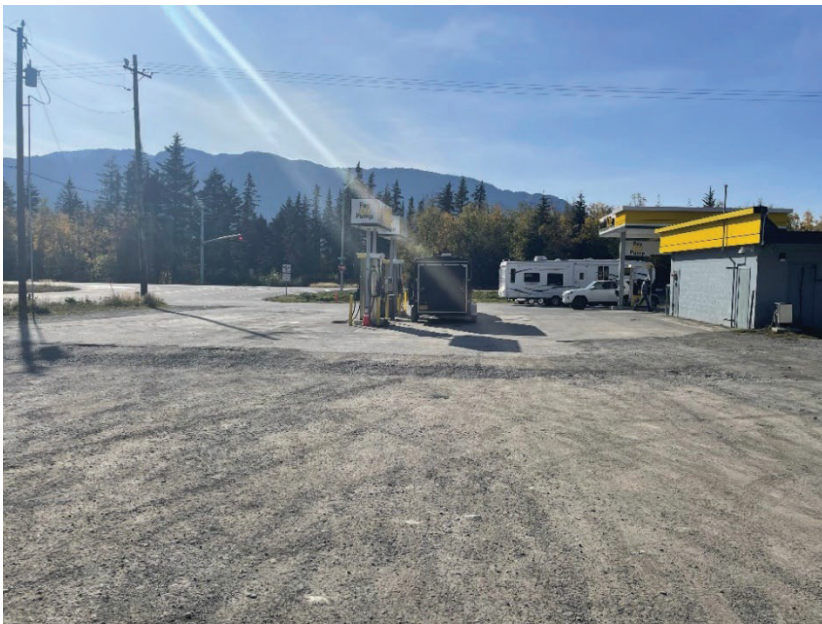
Photo 8: Looking southwest at pump islands and the parking lot of 29383 Seward Highway. (September 27, 2023)

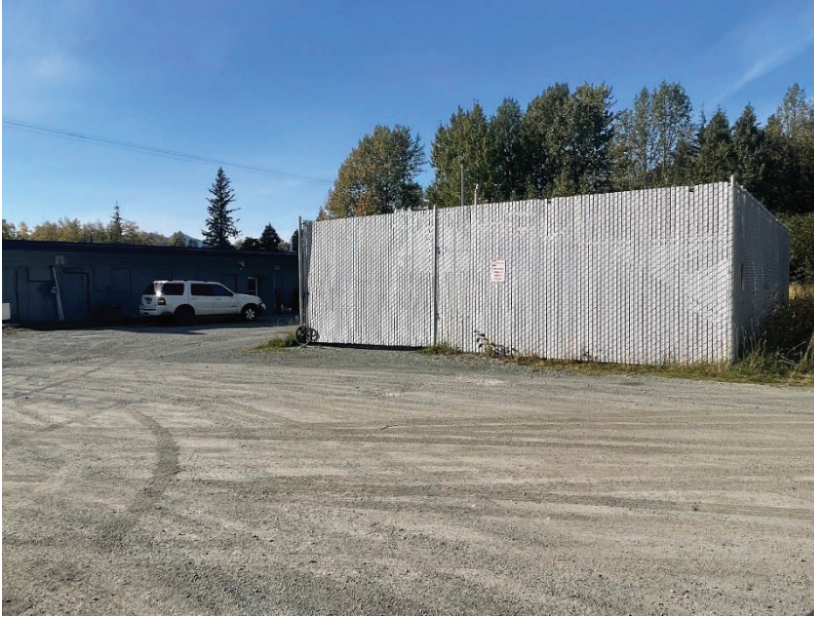
Photo 9: Looking west at the fenced-in AST located south of the Essential One building. (September 27, 2023)

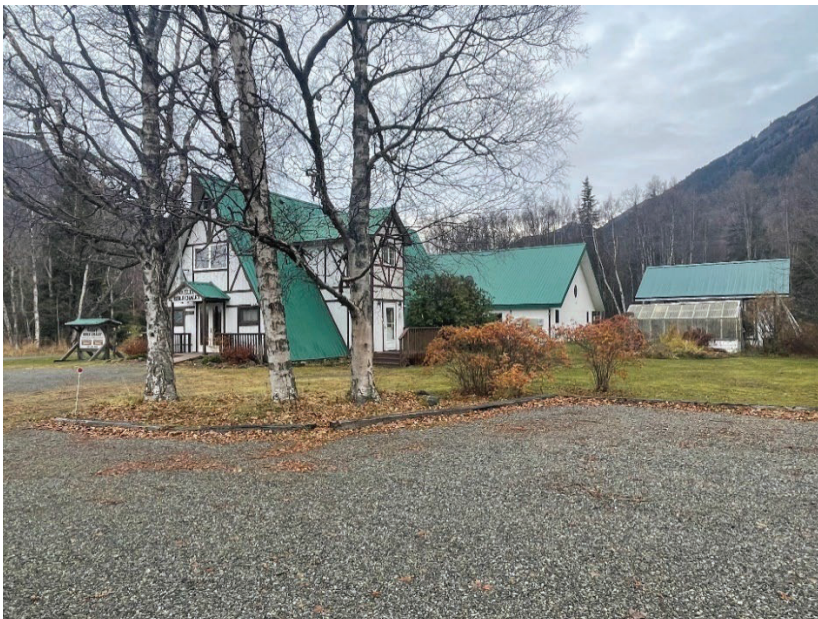
The Valley Bible Chalet located on the mountain side highway near Mile 103 of the XSC, at 29135 Seward Highway (Photo 12). Multiple structures associated with the chalet are located near the XSC boundary. Powerlines with a Chugach Electric Association (CEA) pole-mounted transformer, buried natural gas pipeline markers, and ENSTAR pipeline access were observed in this area (Photo 13).

Photo 12: Looking northwest at the Valley Bible Chalet and associated structures, located near Mile 103 of the XSC. (November 2, 2023)

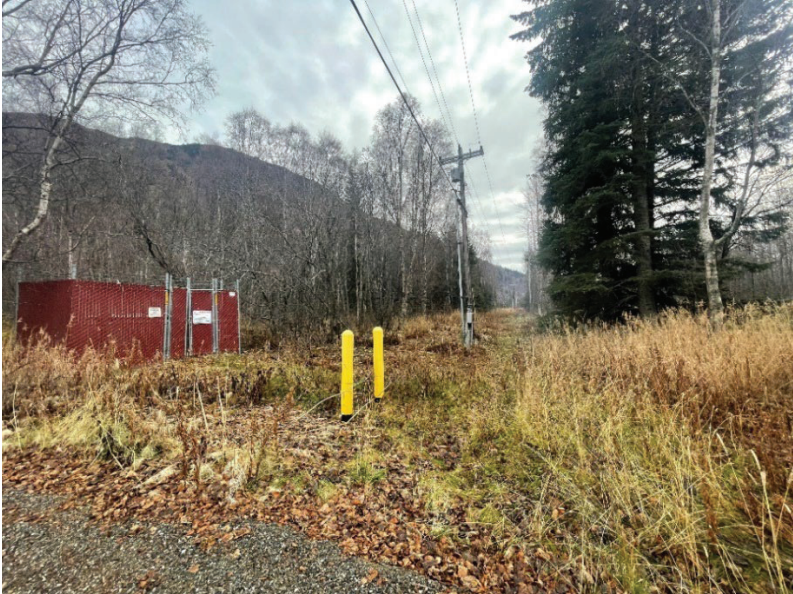
Photo 13: Looking south at powerlines and CEA pole-mounted transformer, buried natural gas pipeline markers, and fenced-in ENSTAR pipeline access, located east of the Valley Bible Chalet. (November 2, 2023)

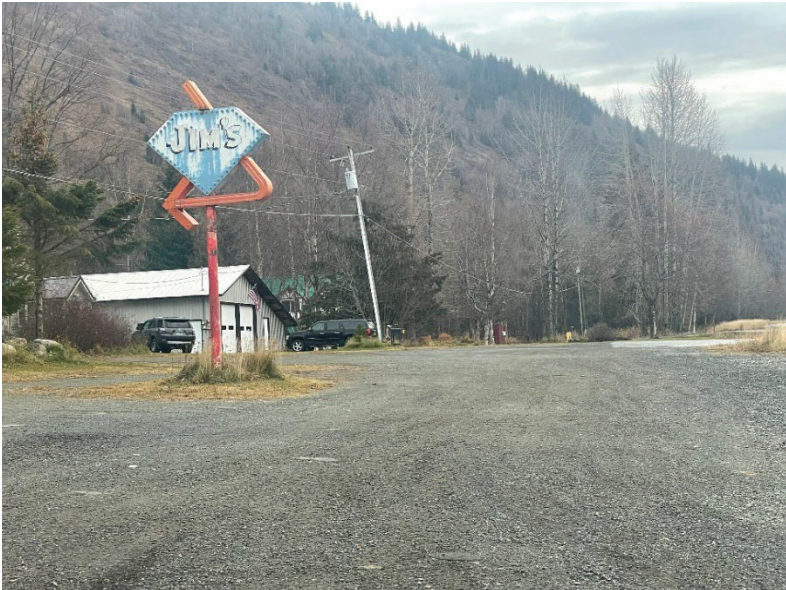
Several residential structures are located along the mountain side of the highway around Mile 103 of the XSC. Powerlines with a CEA pole-mounted transformer run along the XSC. Dimond Jim’s Liquor & Gifts store (Photo 14) and the Brown Bear Saloon are located on the mountain side of the highway, along the Indian Creek. Several 55-gallon drums, a boat, parked cars, and connex were observed alongside and behind the Brown Bear Saloon (Photo 15). A bike path originates from the Brown Bear Saloon parking lot and heads south beneath the Seward Highway to the Chugach State Park Indian Creek parking lot (Photo 16). The bike path continues along Cook Inlet.

Photo 14: Looking south at Dimond Jim's Liquor & Gift shop, unpaved parking lot, residential structures, powerlines, and pole-mounted transformer located near Mile 103 of the XSC. (November 2, 2023)

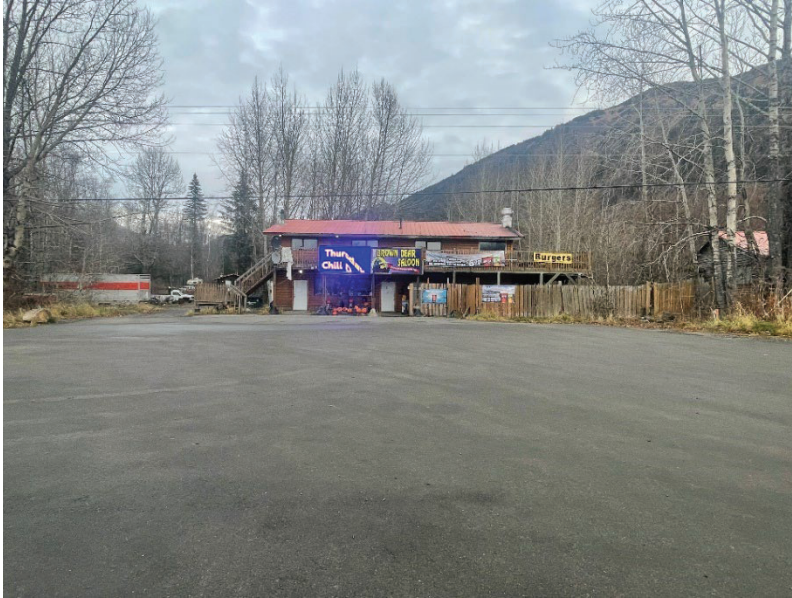
Photo 15: Looking west at the Brown Bear Saloon, located near Mile 103 of the XSC. Several 55-gallon drums, a boat, parked cars, and connex were observed near the structure. (November 2, 2023)

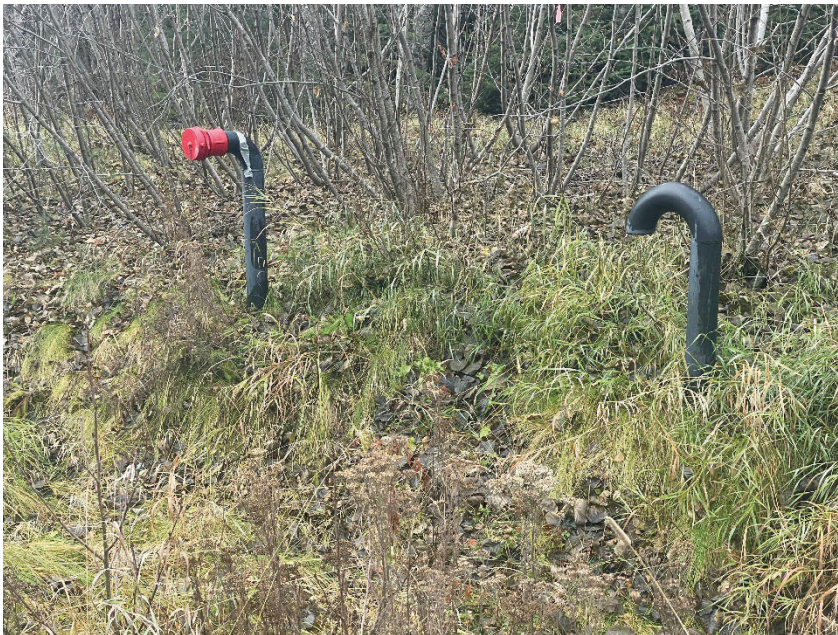
The BBQ Pit is located west of the Brown Bear Saloon along the XSC at the intersection of Boretide Drive and Seward Highway (Photo 17). The Chugach Park View subdivision is located about 500 feet north of Mile 115 of the Seward Highway. Powerlines were observed within the XSC boundary. A 5,000-gallon water tank accessed for firefighting and ports were observed about 300 north of the highway and along Boretide Drive (Photo 18).

Photo 18: Looking south at water tank ports located along Boretide Drive and south of the Chugach Park View Subdivision, near Mile 103.5 of the XSC. (November 2, 2023)

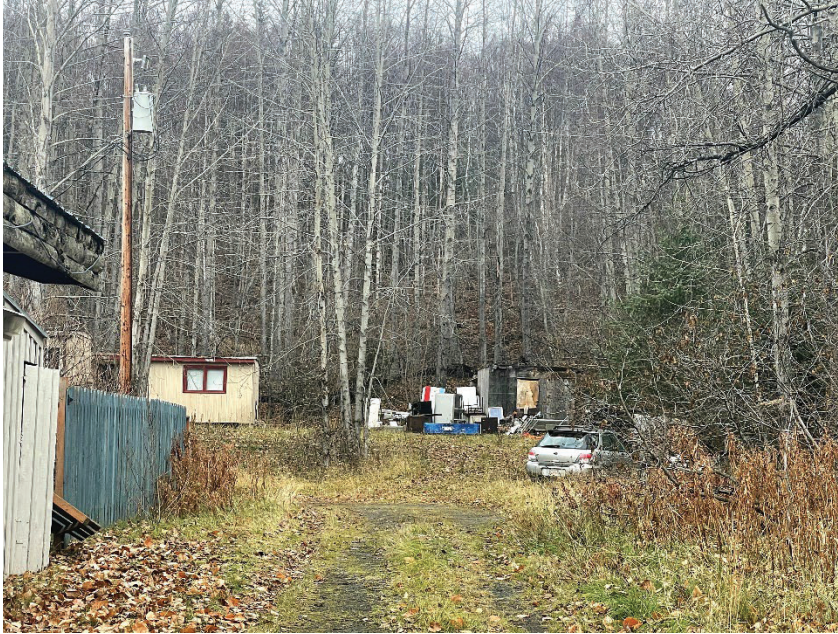
to be abandoned. Refuse was observed near the Indian House restaurant. A multi-unit mobile home structure was observed north of the Indian House. (Photo 21)

Photo 21: Looking west at a shed, refuse, powerlines, pole-mounted transformer, and multi-unit mobile home observed behind the Indian House restaurant. (November 2, 2023)

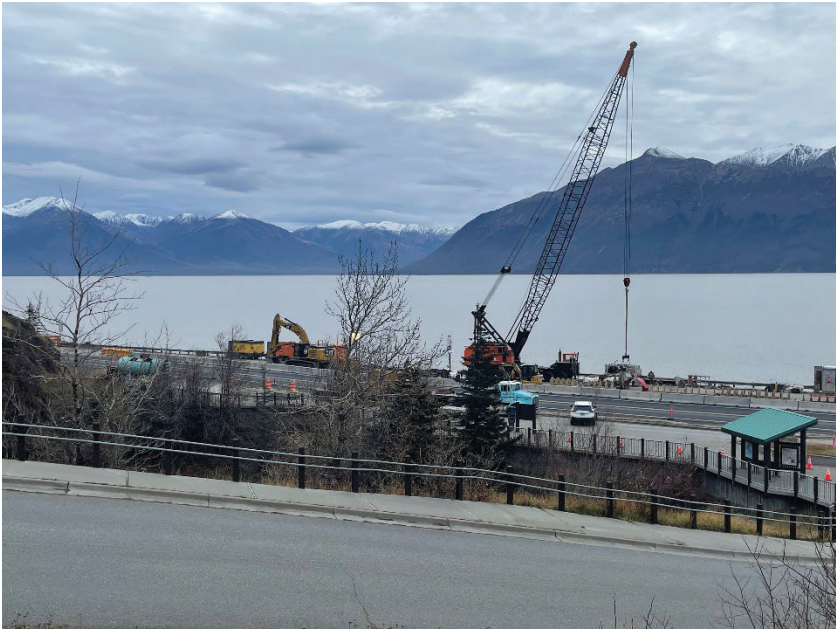
McHugh Creek Scenic Overlook/Trailhead & Picnic Area is located at Mile 112 of the XSC. The lower parking lot was being used as a staging area for construction activities on the railroad tracks running along the inlet side of the Seward Highway. Crains, excavators, trucks, and other construction equipment were observed in this location. (Photo 24)

Photo 24: Looking south at construction activities on the railroad tracks along the Cook Inlet side of the highway near Mile 112 of the XSC. (November 2, 2023)

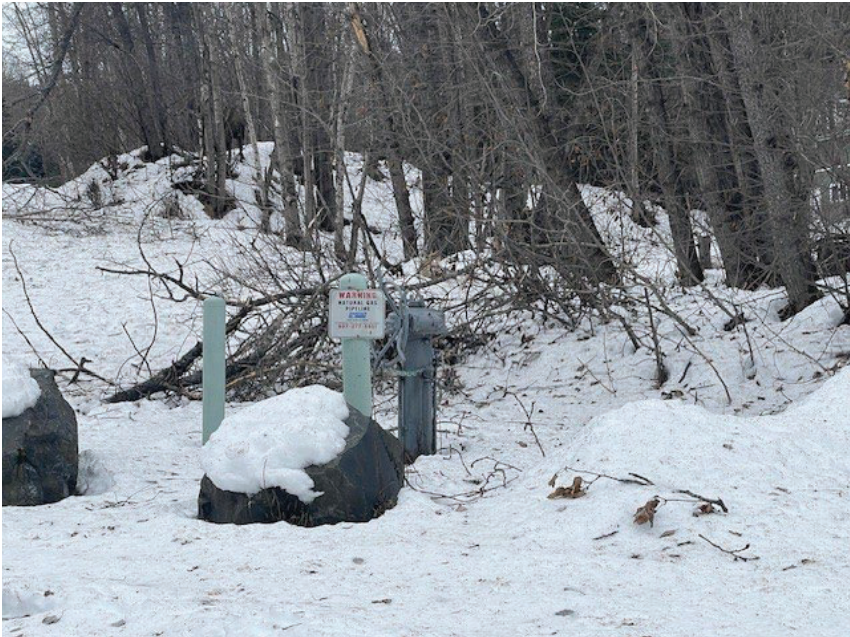
The Chugach State Park Headquarters is located about 300 feet northeast of the Potter Creek trailhead parking lot, on the inlet side of the highway. The headquarters is composed of the Chugach State Park Potter Historic Site, the Potter Section House located at 18620 Seward Highway, and the Gas Line Station Inlet Crossing (Photo 27). Residential structures are located east of the Chugach State Park Headquarters, on the mountain side of the highway. Access to an ENSTAR natural gas pipeline was observed in this area (Photo 28).

Photo 28: Looking northeast at a posted sign and access port for an ENSTAR natural gas pipeline located near Mile 115.25 of the XSC. (December 4, 2023)
