Safer Seward Highway Project  
Seward Highway MP 98.5 to 118,  
Bird Flats to Rabbit Creek  
Project No.: Z566310000/0A31034

# Environmental Assessment

*Appendix R: Environmental Database  
Review and Site Reconnaissance  
Progress Letter*

RE: ENVIRONMENTAL DATABASE REVIEW AND SITE RECONNAISSANCE PROGRESS  
LETTER, SEWARD HIGHWAY 98.5 - 118 CORRIDOR, ALASKA

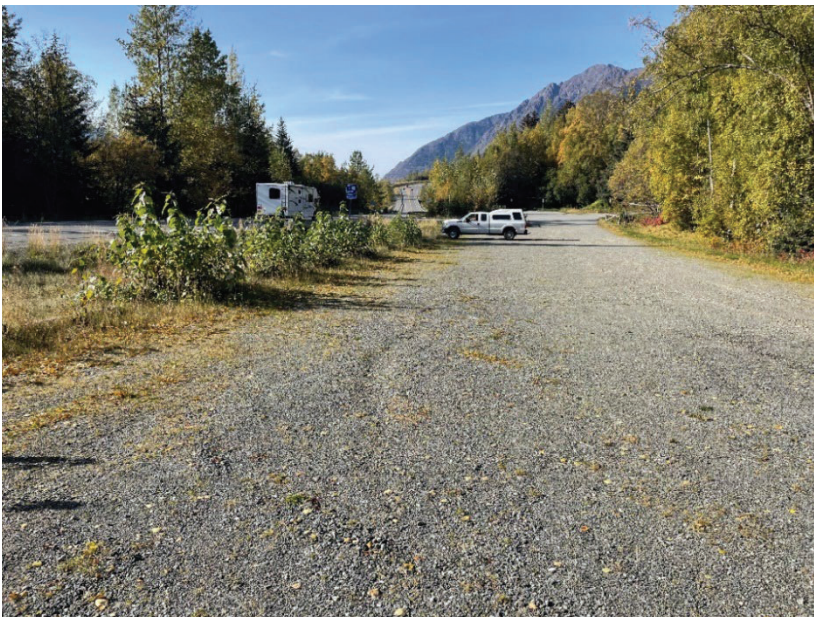
The Bird Creek overflow unpaved parking lot and main Bird Creek paved parking lot are located at Miles 101.25 and 101.5 of the XSC, respectively (Photos 10 and 11).

Photo 10: Looking northwest at the unpaved overflow lot for Bird Creek, near Mile 101.25 of the XSC. (September 27, 2023)

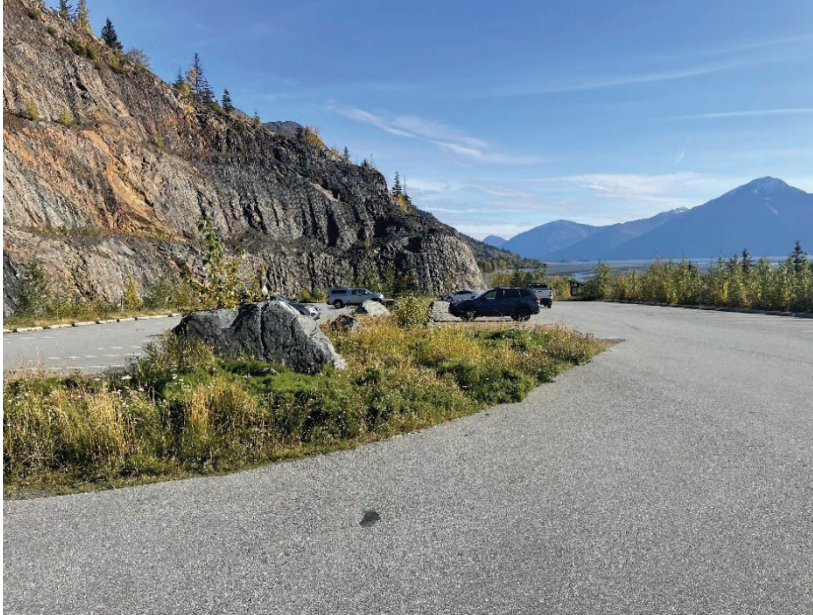
Photo 11: Looking southeast at the Bird Creek paved parking lot, located near Mile 101.5 of the XSC. (September 27, 2023)

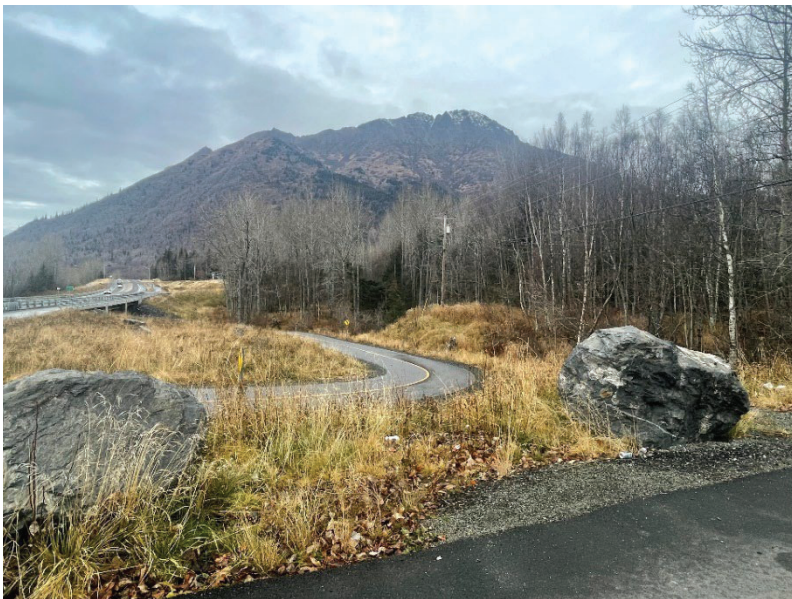
Several residential structures are located along the mountain side of the highway around Mile 103 of the XSC. Powerlines with a CEA pole-mounted transformer run along the XSC. Dimond Jim’s Liquor & Gifts store (Photo 14) and the Brown Bear Saloon are located on the mountain side of the highway, along the Indian Creek. Several 55-gallon drums, a boat, parked cars, and connex were observed alongside and behind the Brown Bear Saloon (Photo 15). A bike path originates from the Brown Bear Saloon parking lot and heads south beneath the Seward Highway to the Chugach State Park Indian Creek parking lot (Photo 16). The bike path continues along Cook Inlet.

Photo 16: Looking north at a paved bike path located north of the Brown Bear Saloon, near Mile 103 of the XSC that heads west towards and beneath the Seward Highway. (November 2, 2023)

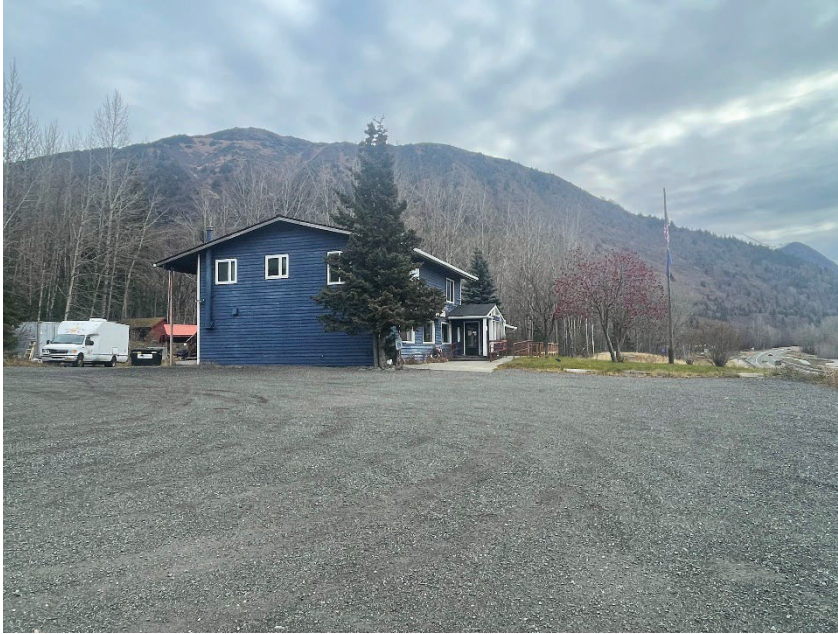
The BBQ Pit is located west of the Brown Bear Saloon along the XSC at the intersection of Boretide Drive and Seward Highway (Photo 17). The Chugach Park View subdivision is located about 500 feet north of Mile 115 of the Seward Highway. Powerlines were observed within the XSC boundary. A 5,000-gallon water tank accessed for firefighting and ports were observed about 300 north of the highway and along Boretide Drive (Photo 18).

Photo 17: Looking south at the BBQ Pit restaurant and unpaved parking lot located at 27957 Seward Highway, near Mile 103.5 of the XSC. (November 2, 2023)

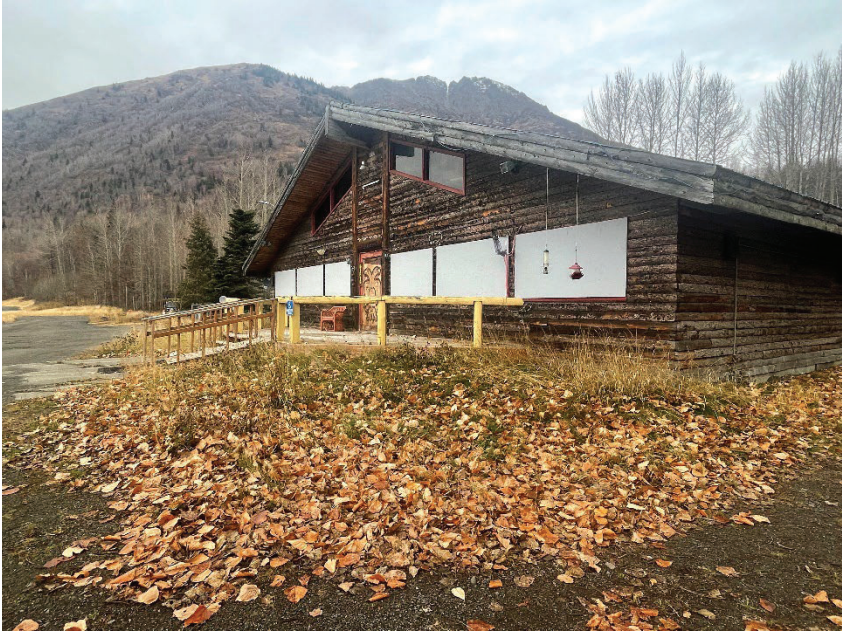
The Indian House restaurant (Photo 19) and Birch & Alder (Photo 20) restaurant are located around Mile 103.5 of the XSC. The Indian House restaurant was boarded up and appeared

to be abandoned. Refuse was observed near the Indian House restaurant. A multi-unit mobile home structure was observed north of the Indian House. (Photo 21)

Photo 19: Looking north at the Indian House restaurant located around Mile 103.5 of the XSC. (November 2, 2023)

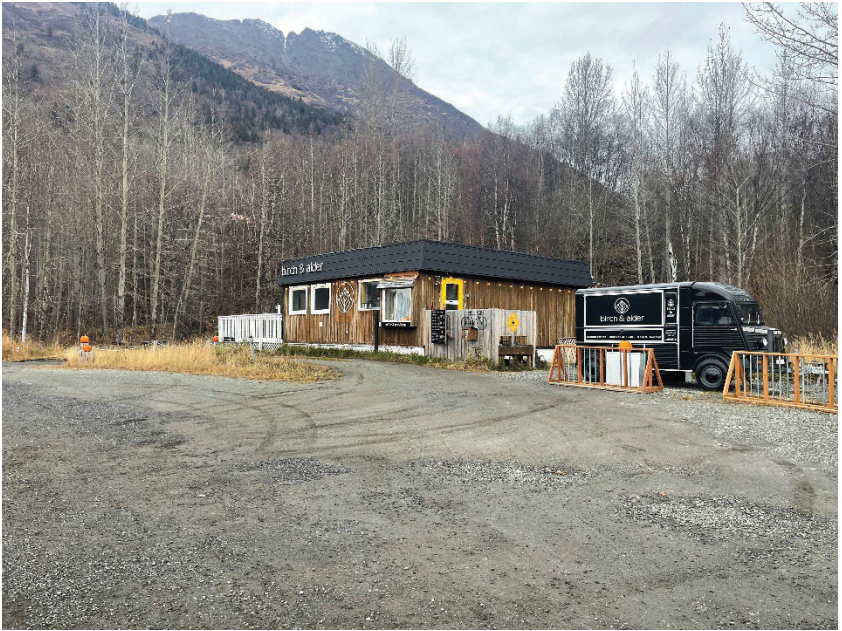
Photo 20: Looking northwest at the Birch & Alder restaurant and unpaved parking lot located around Mile 103.5 of the XSC. (November 2, 2023)

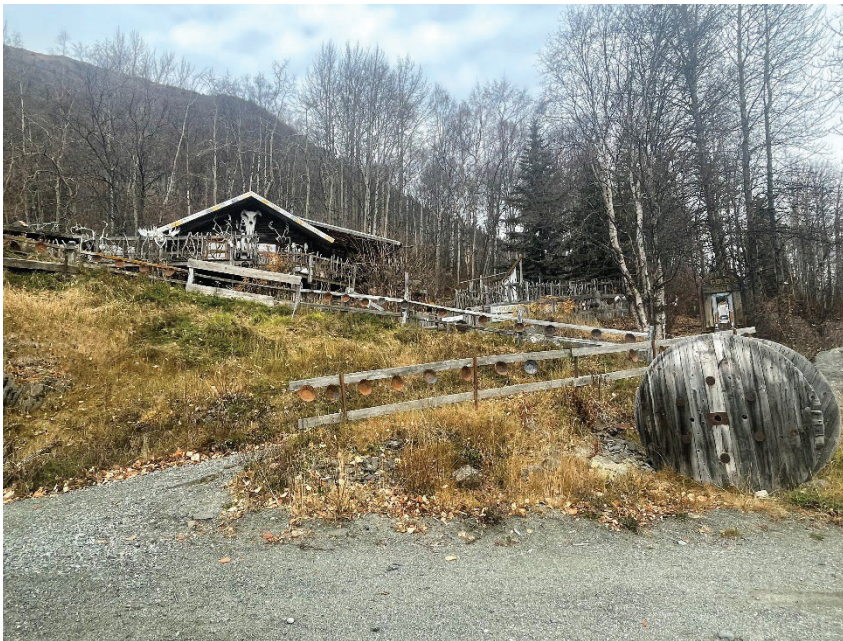
The Indian Valley Mine is located around Mile 104 of the XSC (Photo 22). Only the parking lot was observed during the site visit.

Photo 22: Looking northwest at the Indian Valley Mine is located around Mile 104 of the XSC. (November 2, 2023)

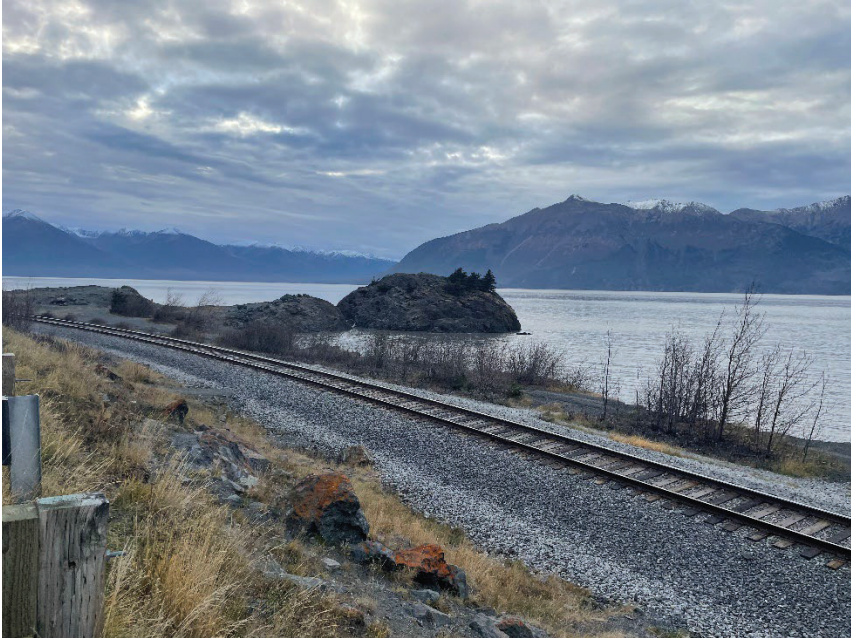
Beluga Point scenic overlooks and parking lot are located on the inlet side of the highway at Mile 110 of the XSC (Photo 23).

Photo 23: Looking southeast at the Beluga Point from a scenic overlook located at Mile 110 of the XSC. (November 2, 2023)

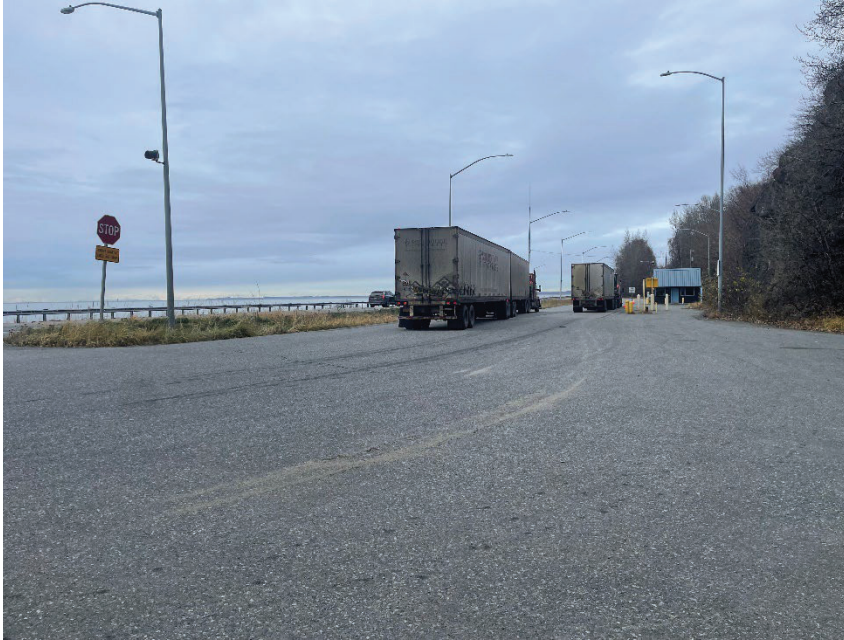
An Alaska Department of Transportation (ADOT) weigh station is located at Mile 114.5 of the XSC (Photo 25).

Photo 25: Looking northwest at the ADOT weigh station located near Mile 114.5 of the XSC. (November 2, 2023)

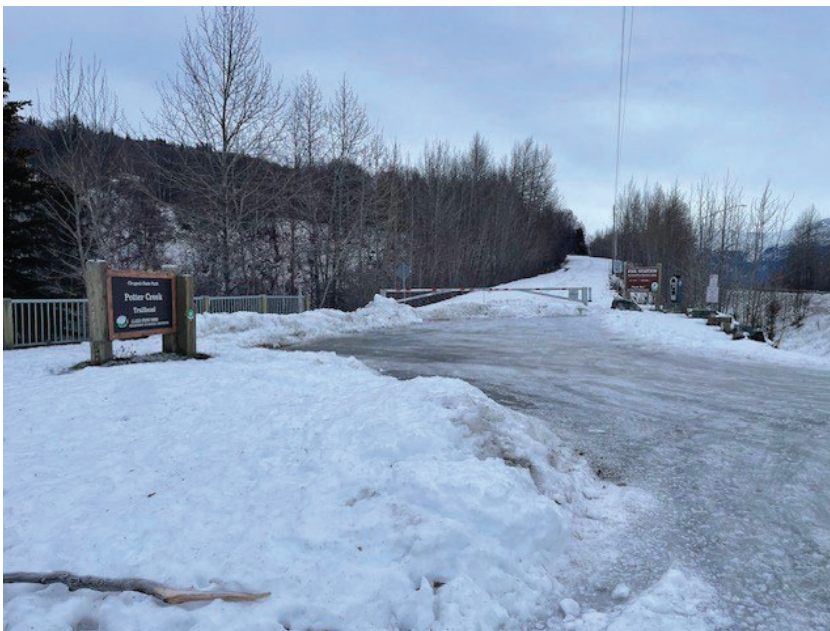
The Potter Creek trail head parking lot and the beginning of the Anchorage Soil and Water Conservation district is located at Mile 115 of the XSC. Powerlines were observed within the XSC (Photo 26).

Photo 26: Looking southeast at the Potter Creek trail head parking lot, located at Mile 115 of the XSC. (December 4, 2023)

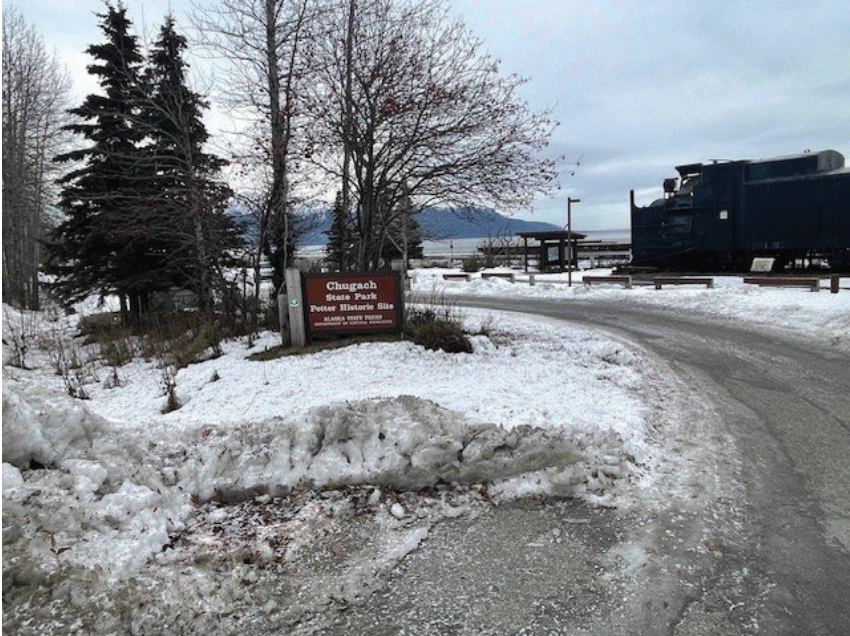
The Chugach State Park Headquarters is located about 300 feet northeast of the Potter Creek trailhead parking lot, on the inlet side of the highway. The headquarters is composed of the Chugach State Park Potter Historic Site, the Potter Section House located at 18620 Seward Highway, and the Gas Line Station Inlet Crossing (Photo 27). Residential structures are located east of the Chugach State Park Headquarters, on the mountain side of the highway. Access to an ENSTAR natural gas pipeline was observed in this area (Photo 28).

Photo 27: Looking south at the Chugach State Park Potter Historic Site, located along the Cook Inlet side of the XSC near Mile 115.25. (December 4, 2023)

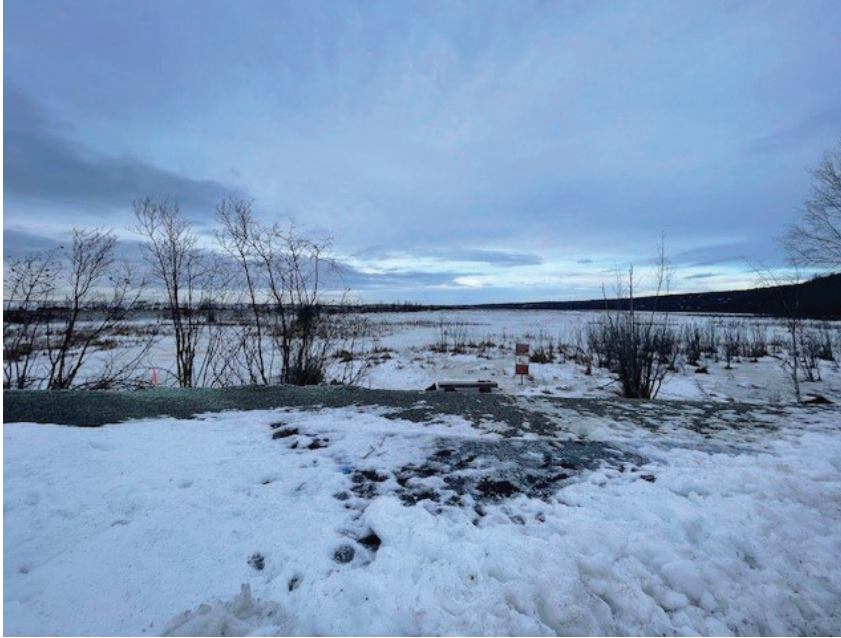
Potter's Marsh was observed along the mountain side of the highway from Mile 115.5 through Mile 117.5 of the XSC (Photo 29). According to the U.S. Fish and Wildlife Service (USFWS) National Wetlands Inventory database, Potter's Marsh includes about 374.28 acres of freshwater emergent wetlands, about 50.24 acres of freshwater forested/shrub wetlands, about 29.42 acres of estuarine and marine wetlands, and a 10.47 freshwater pond. A parking lot for Potter's Marsh is located near Mile 115.5 of the XSC. The Potter Marsh Wildlife

Photo 29: Looking north at Potter Marsh from the parking area located at Mile 115.5 of the XSC. (December 4, 2023)

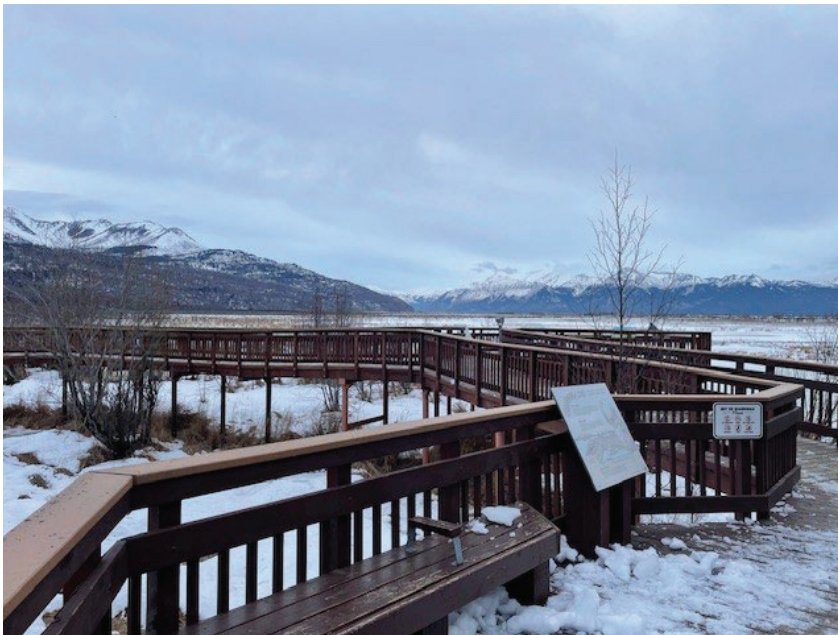
Viewing Boardwalk and parking area is accessed off 154th Avenue, near Mile 117.5 of the XSC (Photo 30). Residential structures and Alaska Frontier Services are located off 154th Avenue (Photo 31). The Rabbit Creek Shooting Range is located at 15222 New Seward Highway, on the inlet side of the highway (Photo 32), near Mile 117.5 of the XSC.

Photo 30: Looking south at the Potter Marsh Wildlife Viewing Boardwalk located near Mile 117.5 of the XSC. (December 4, 2023)

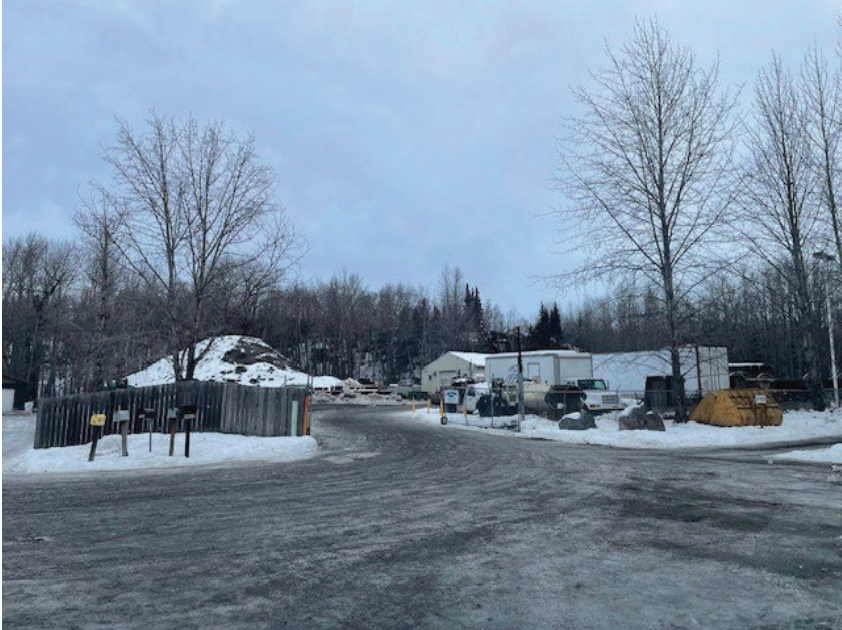
Photo 31: Looking west at Alaska Frontier Services located off 154<sup>th</sup> Avenue and north of Potter Marh, near Mile 117.75 of the XSC. (December 4, 2023)

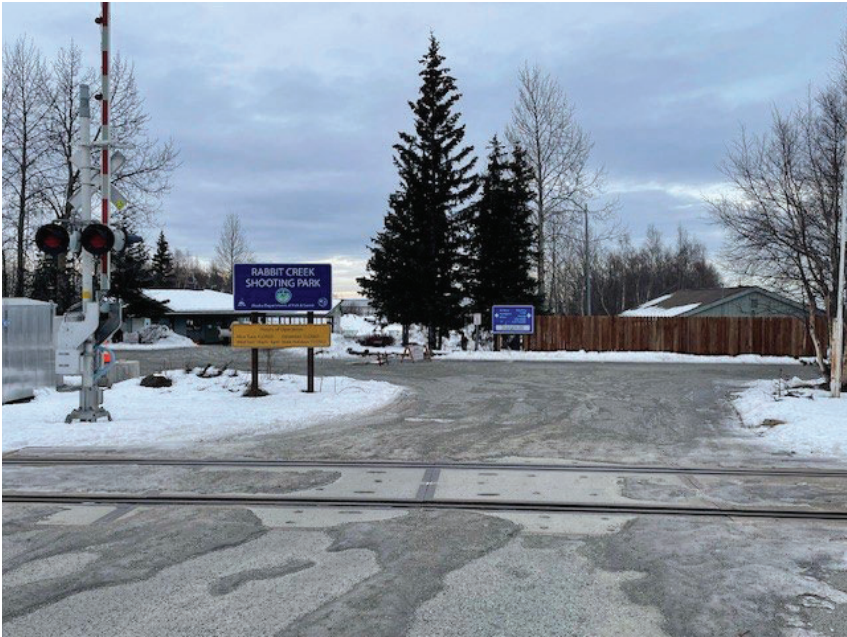
Photo 32: Looking west at the Rabbit Creek Shooting Range located on the Cook Inlet side of the XSC, near Mile 117.75. (December 4, 2023)
