Safer Seward Highway Project
Seward Highway MP 98.5 to 118,
Bird Flats to Rabbit Creek
Project No.: Z566310000/0A31034

*Appendix H: Geotechnical Data Review,
Seward Highway Milepost 98.5–118,
Anchorage, Alaska*

GEOTECHNICAL DATA REVIEW

Seward Highway Milepost 98.5-118

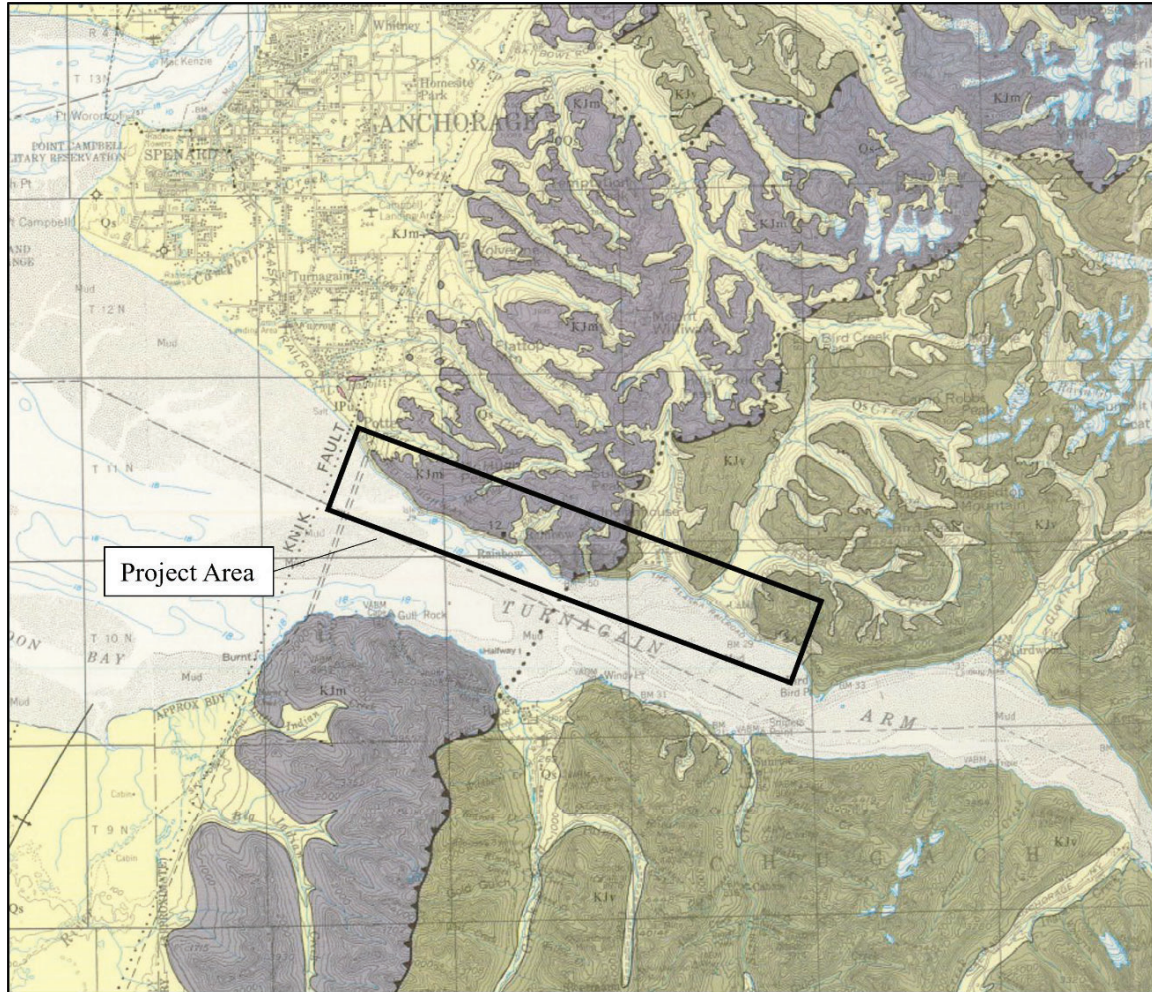
Exhibit 2-1: Regional Geology along Seward Highway

Map Units: KJm – Metasedimentary Rocks with Volcanics; KJv - Metasedimentary Rocks; Qs – Surficial Deposits.
Taken from *Geologic Map of Cook Inlet Area, Alaska* (Magoon, Adkison, and Egbert, 1976).

The Quaternary deposits atop the bedrock within the project area generally consist of overconsolidated till with interbedded and interfingering alluvial and marine sediments at the surface. The widespread complex of unconsolidated deposits result directly or indirectly from glaciation, from its subsequent stream activity, or from wave action. Unconsolidated deposits in the project area typically consist of glacial moraine, glaciofluvial and alluvial silts, sands and gravels, and localized fills. The thickness of these surficial deposits varies greatly and deposition as well as erosion occurs very quickly due to the topography and environment. Near major stream valleys, outwash and meltwater channel fills locally, bury, or are inset into glacial drift. Stream floodplains are underlain by granular alluvium and bounded by steep, glacially carved mountain walls. Various forms of colluvium, including rockfalls, slumps, and mudflows, are scattered along the walls of stream valleys.

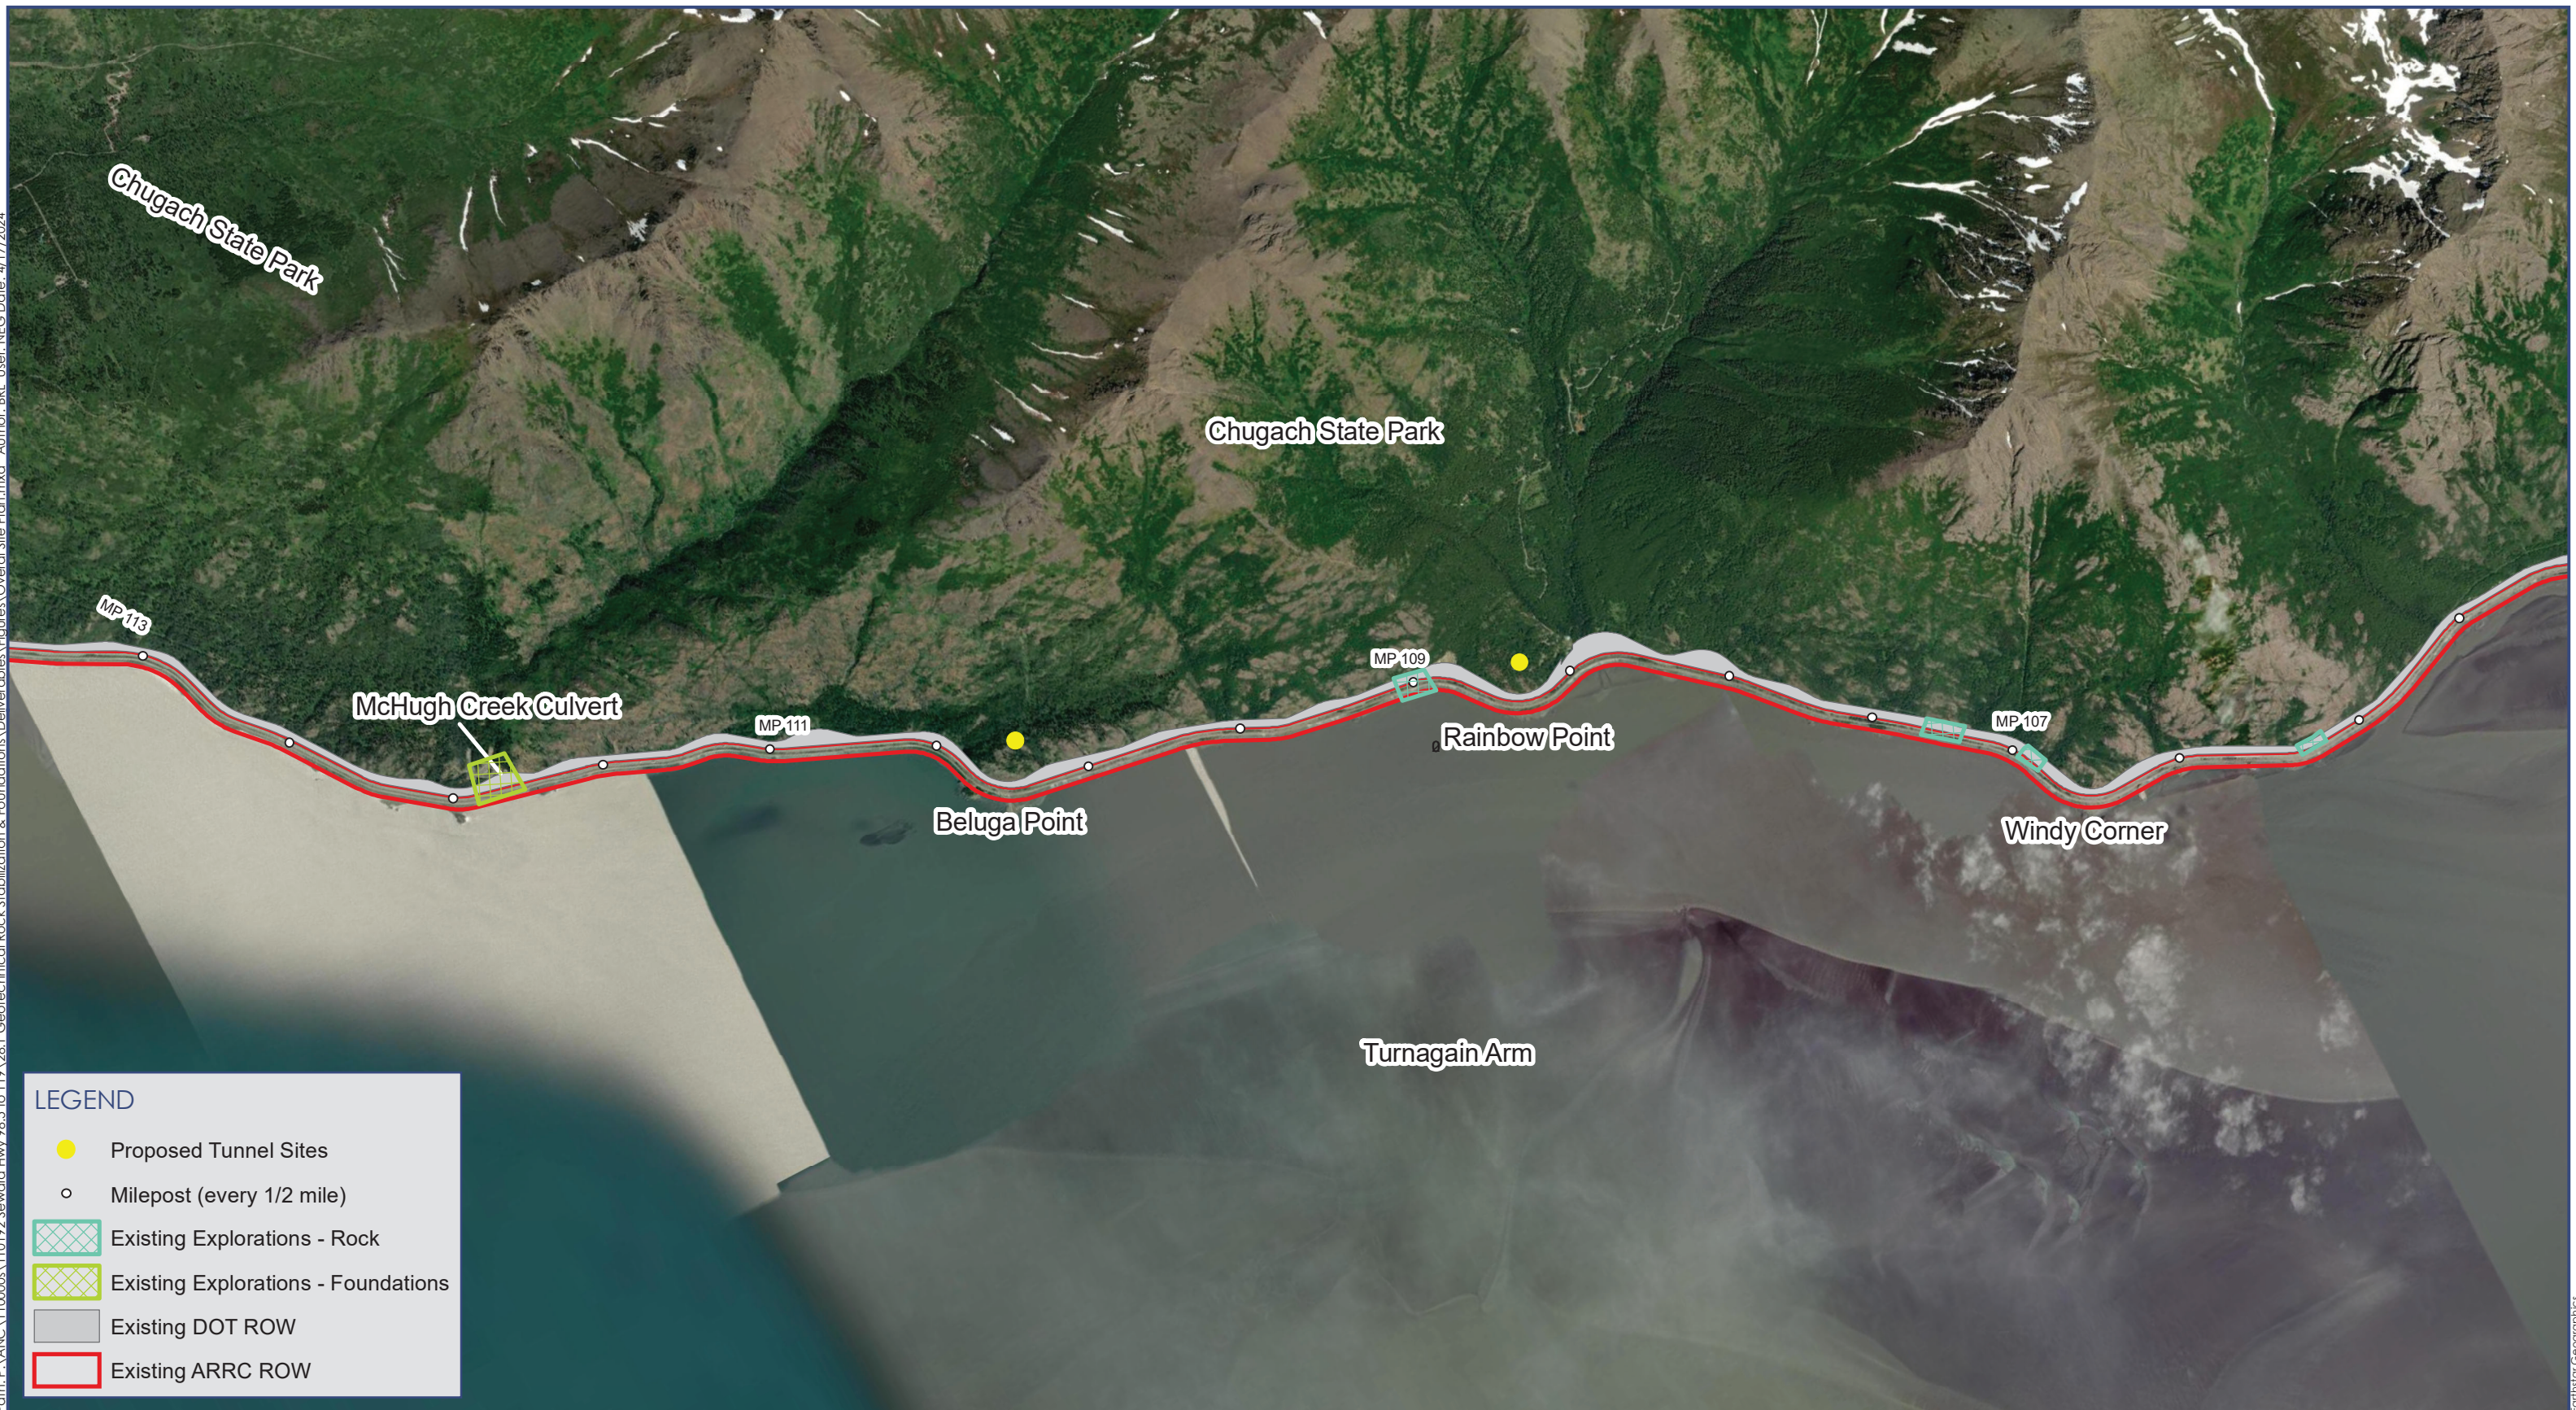
1. Mileposts, existing DOT ROW, and ARRC ROW provided courtesy of Safer Seward Highway Hub, 2023.
2. Foundations explorations: Alaska Department of Transportation and Public Facilities, 2020, Geotechnical Report, Anchorage Area Drainage Improvements FY2019 – McHugh Creek, Central Region Materials.
3. Rock explorations at MP 109: Alaska Department of Transportation and Public Facilities, 2016, Rock Fall Analysis Seward Highway MP 104-115, Central Region Materials
4. Rock explorations at MPs 107.25, 106.9, and 106.2: Alaska Department of Transportation and Public Facilities, 2010, Geotechnical Observations and Summary – Proposed Material Sites, Seward Highway MP 105-107, Central Region Materials

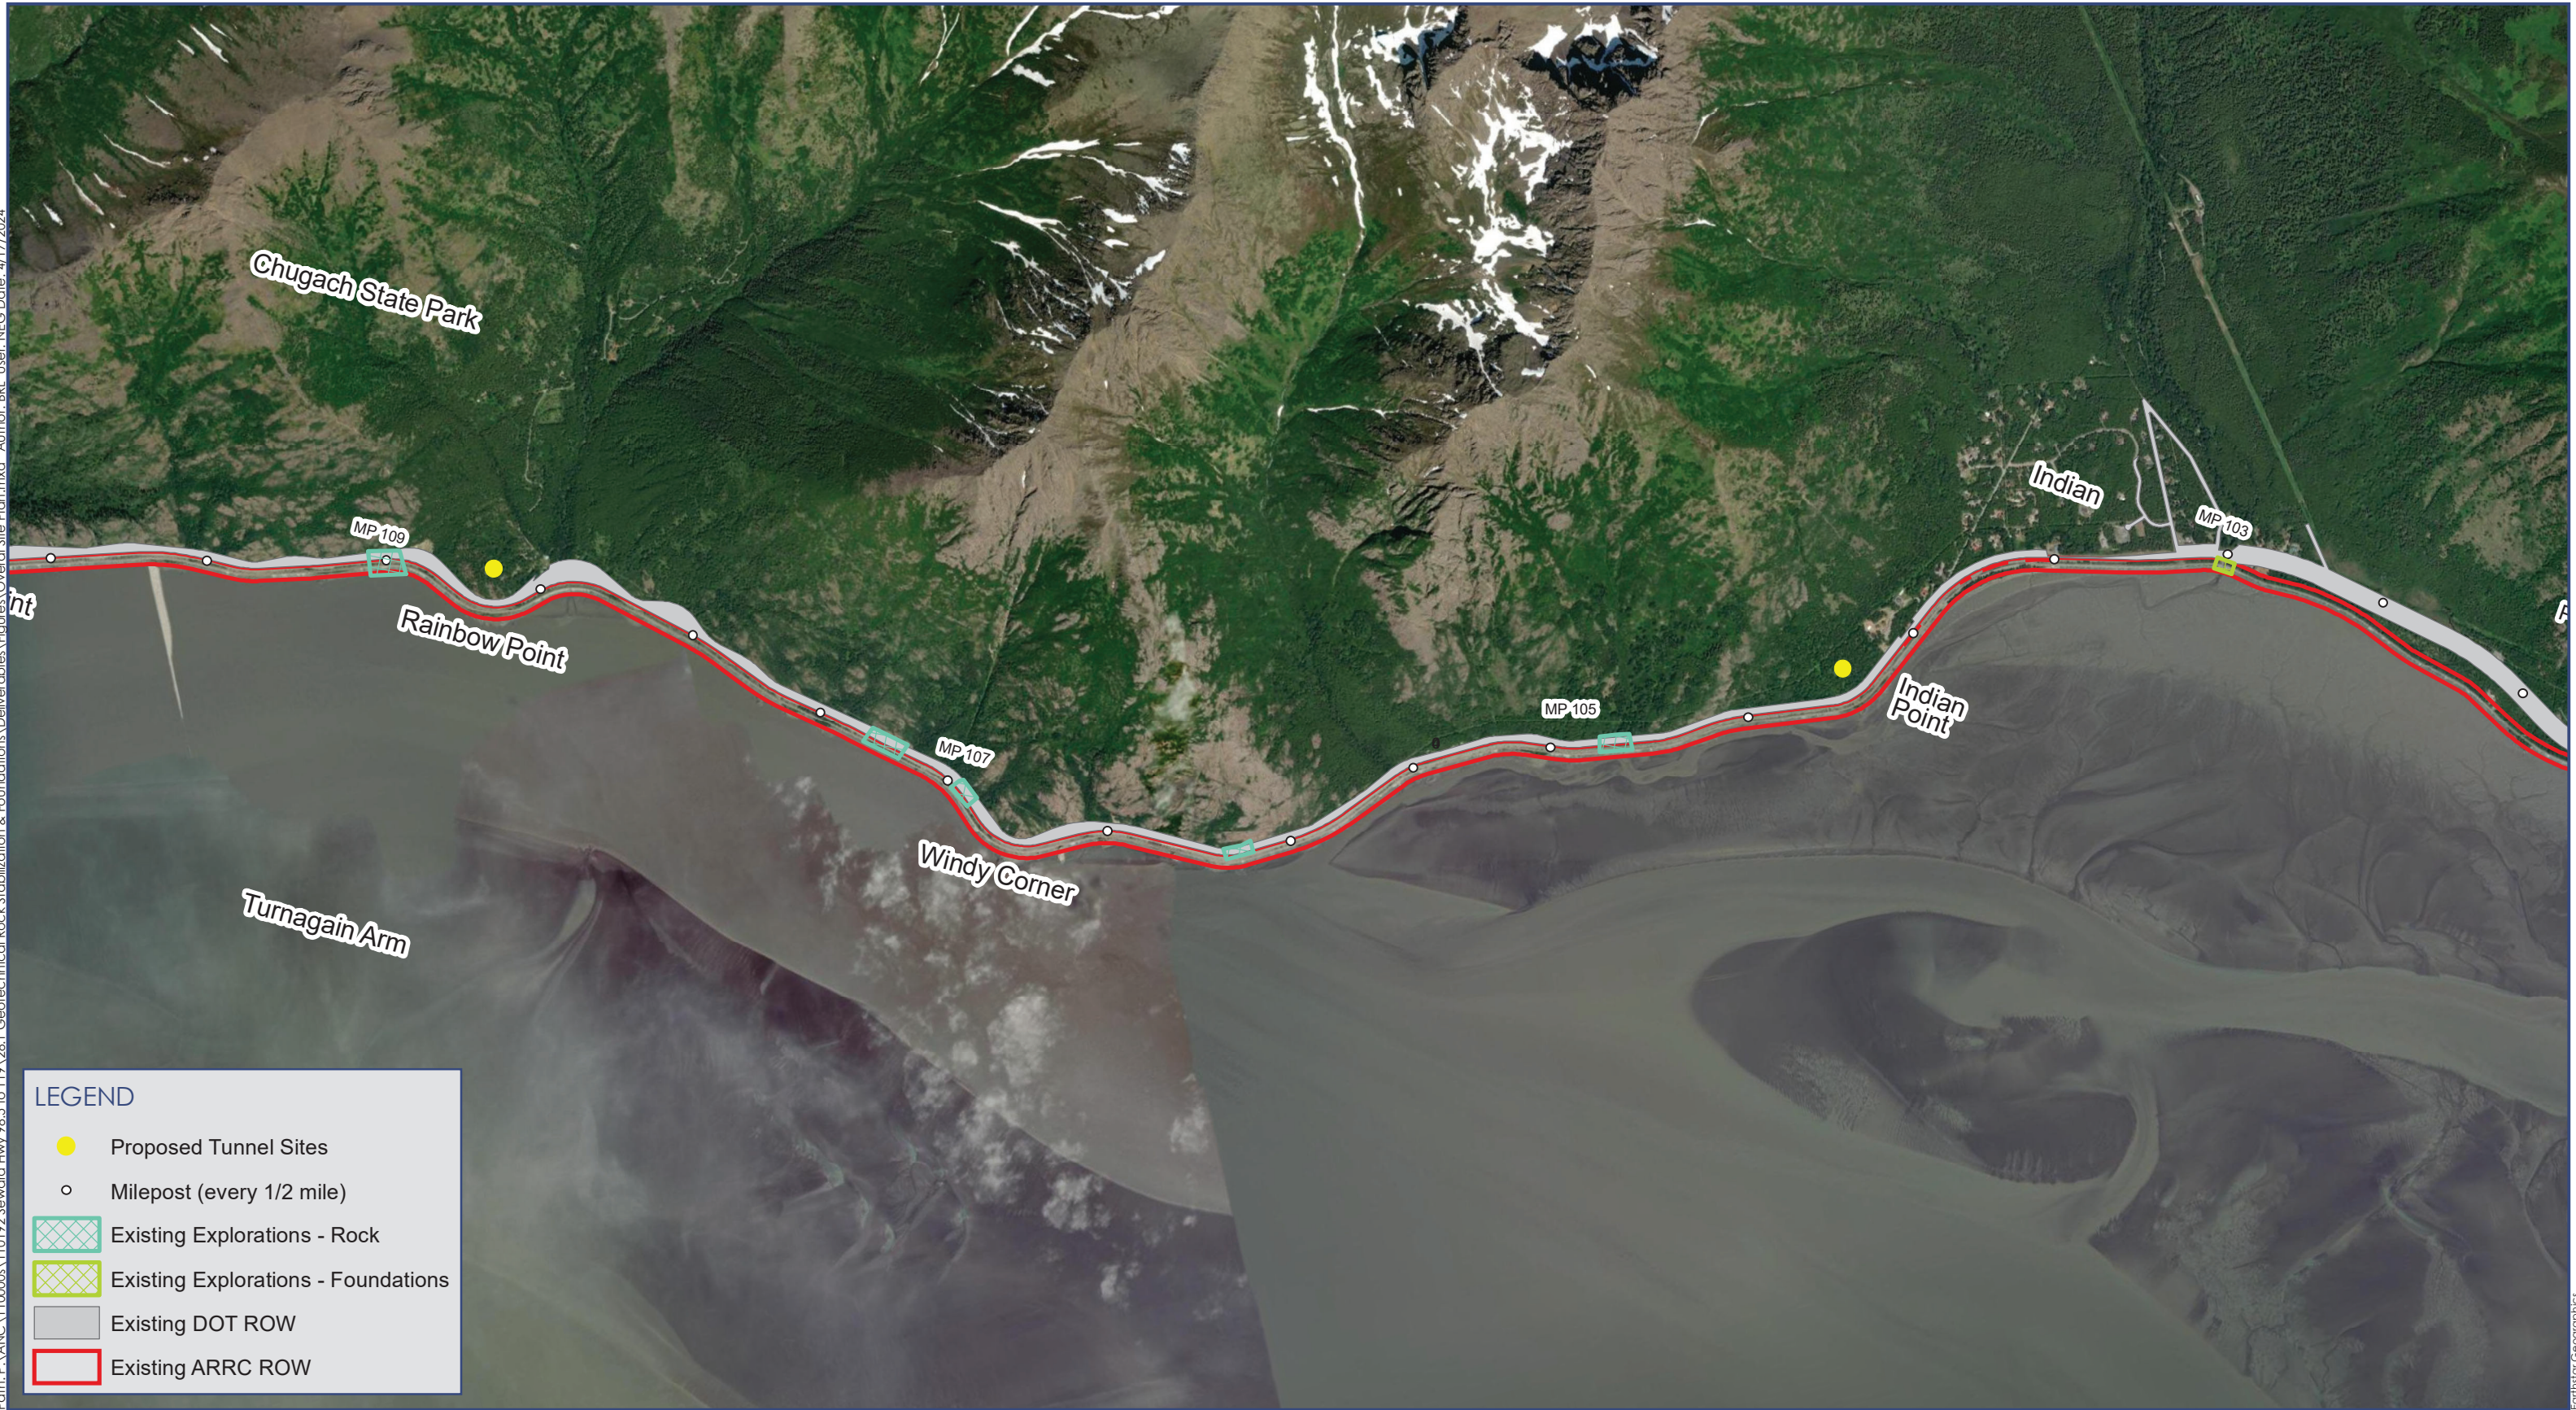
1. Mileposts, existing DOT ROW, and ARRC ROW provided courtesy of Safer Seward Highway Hub, 2023.
2. Foundations explorations: - Alaska Department of Transportation and Public Facilities, 2018, Foundation Geology Report, Indian Creek Bridge Replacement, Seward Highway MP 99 to 105 Improvements, Statewide Geotechnical Services.
3. Rock explorations at MP 109: Alaska Department of Transportation and Public Facilities, 2016, Rock Fall Analysis Seward Highway MP 104-115, Central Region Materials
4. Rock explorations at MPs 107.25, 106.9, 106.2, and 104.8: Alaska Department of Transportation and Public Facilities, 2010, Geotechnical Observations and Summary – Proposed Material Sites, Seward Highway MP 105-107, Central Region Materials

Indian Creek Bridge is a newer bridge, replaced in 2021-2022. Numerous test holes were drilled to support the foundation design of the newly constructed bridge. These exploration efforts included standard geotechnical borings with SPT sampling as well as cone penetrometer testing. The test holes generally encountered approximately 0.2 to 0.5 feet of asphalt overlying fill ranging from depths of 6.5 to 13 feet below ground surface bgs. In general, the native soils encountered consisted of predominantly granular soils, mostly poorly graded sand or gravel with silt and silty sand. In some test holes, fine grained soils such as silt or silt with sand was observed and some boulders were observed. It was noted that one test hole encountered what was interpreted as weathered bedrock at 110 feet bgs. Further interpretations of bedrock depths were supported by two seismic lines that were

run roughly parallel to the highway, which found bedrock depths vary from 97 to 127 feet bgs (AKDOT&PF 2018).
